GEOLOGY OF SOUTHERN CALIFORNIA

CHAPTER X ENGINEERING ASPECTS OF GEOLOGY

1. EARTHQUAKES AND EARTHQUAKE DAMAGE IN SOUTHERN CALIFORNIA*

BY CHARLES F. RICHTER †

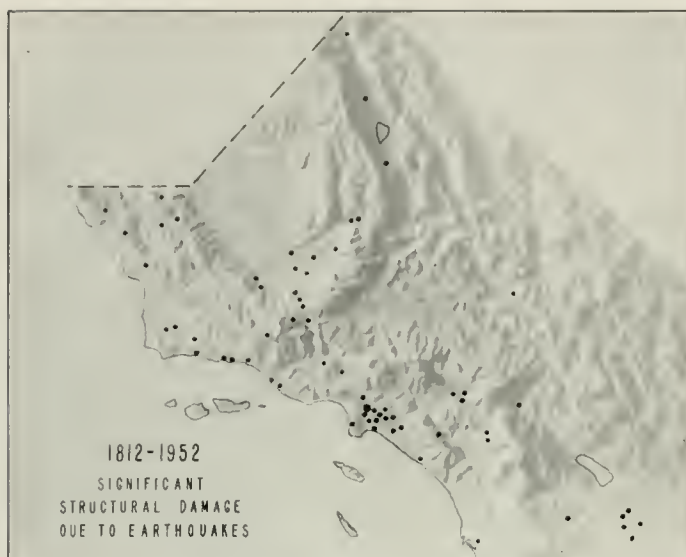
FIGURE 1. Relief map of southern California showing areas where significant structural damage has been caused by earthquakes during the period 1812-1952.

The accompanying map (fig. 1) shows communities and areas in southern California where serious earthquake damage (intensity VIII or over, modified Mercalli 1931) has occurred during the relatively brief period of historic record. Naturally these indications are infrequent in the thinly populated desert and mountain regions. The fact that any one community has escaped in the short time of record is no guarantee of future immunity. It will be noted that the distribution of earthquake damage is rather general.

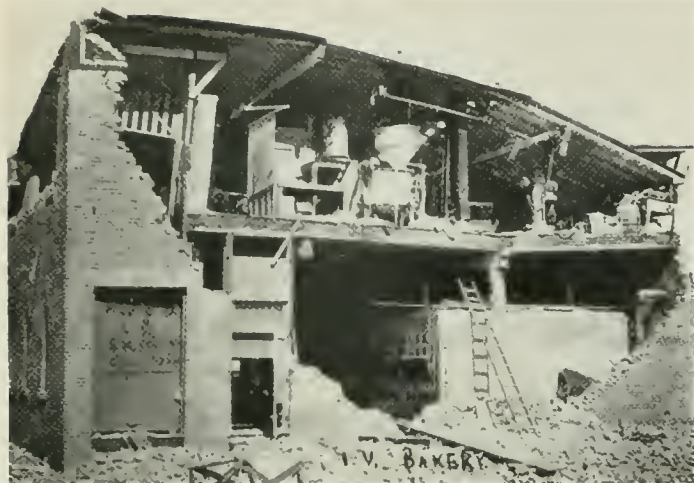
FIGURE 2. Damage to weak masonry, El Centro, 1915. Seis. Soc. Amer., Bull., vol. 5, plate 14.

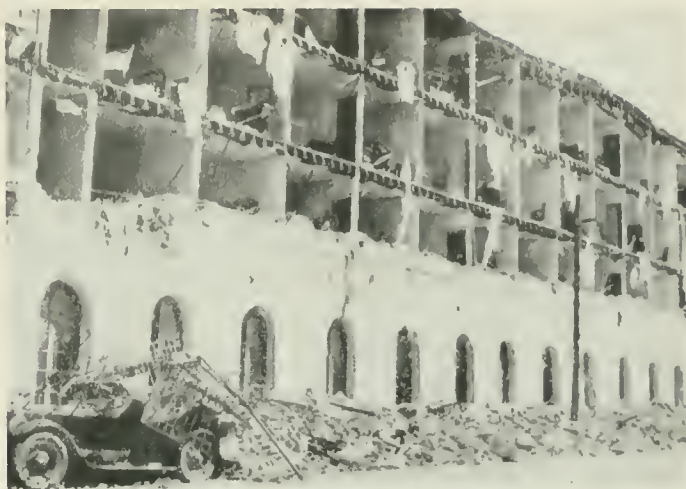
FIGURE 4. Damage to weak masonry, frame structure with brick veneer, Santa Barbara, 1925. Seis. Soc. Amer., Bull., vol. 15, plate 30.

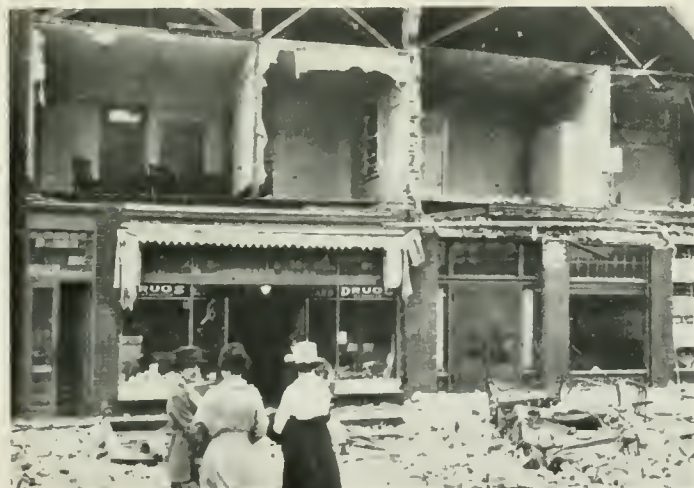
FIGURE 3. Damage to weak masonry, Inglewood, 1920. Separation of bricks was due to weak mortar. Seis. Soc. Amer., Bull., vol. 10, plate 8. *Photo by Los Angeles Times.*

Mortar often has been of poor quality or poorly applied. When a California brick structure is cracked by earthquake motion or by other causes, the cracks almost invariably pass around the bricks, not through them. The Long Beach earthquake of 1933 developed a vast supply of good second-hand bricks; jobbers found that bricks from damaged structures could be cleaned perfectly by hosing off the remains of the mortar, leaving them as good as new.

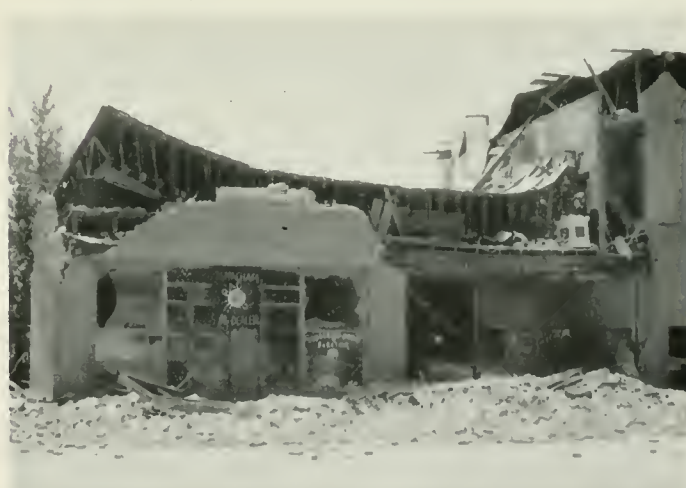
FIGURE 5. Severely damaged building housing Masonic Lodge, Tehachapi, 1952. *Photo by F. E. Lechner.*

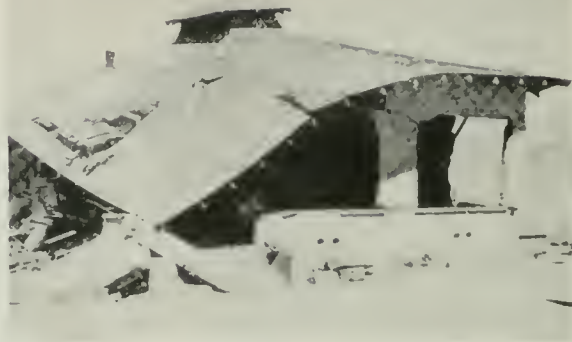
FIGURE 6. Cummings Valley School, west of Tehachapi, 1952. Constructed prior to 1933 of concrete that was nominally but not effectively reinforced. Photo by State Division of Architecture.

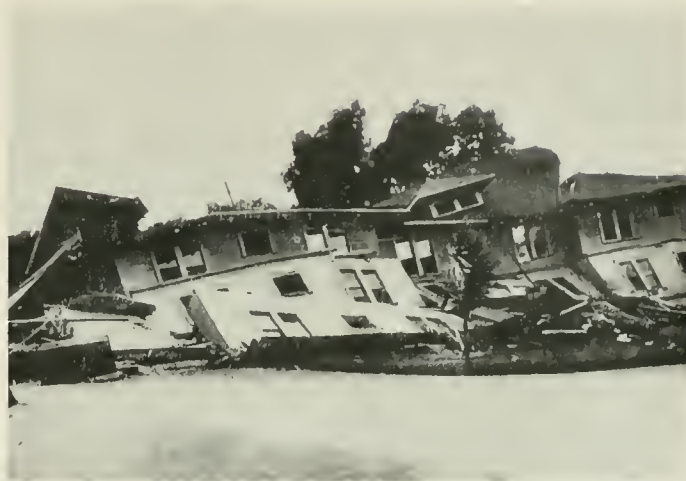
FIGURE 7. Collapse of weak frame structure, Hotel in San Jose, 1906, California Earthquake Commission Report.

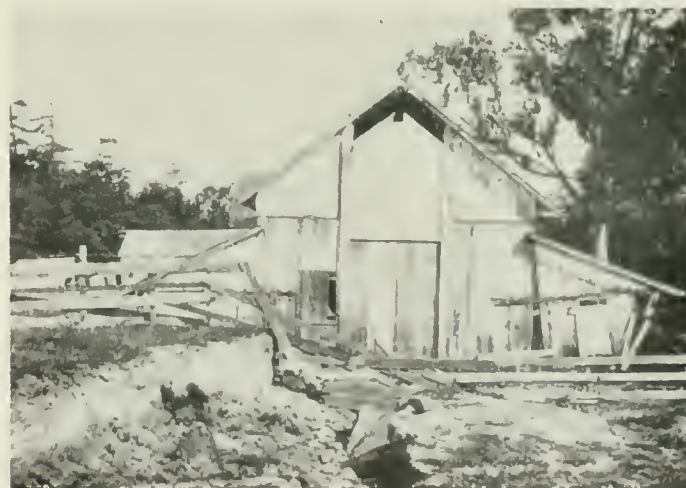
FIGURE 8. Barn not seriously damaged, although fault trace passed under one corner, 1906. Near Olema, California Earthquake Commission Report
